DWPC INSPECTION DIGITAL PHOTOGRAPH PHOTOCOPIES

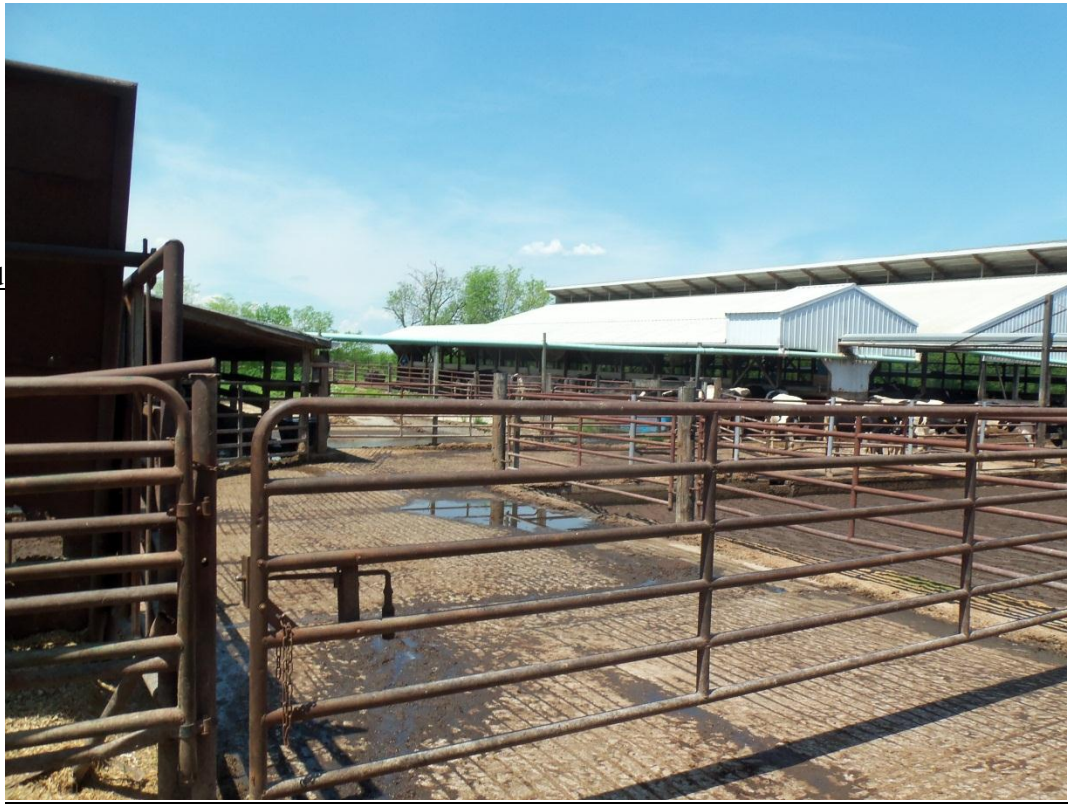
Photo # 001
Date: May 8, 2013
Time: 11:10 a.m.
Taken By: Brian Rodely DWPC/FOS
Facility: Thole Ag, Inc.
Location: E of Middle Herd Building
Notes: This is photograph a
portion of the concrete
feedlot area. Note that the
buildings in the background
are equipped with
guttering.

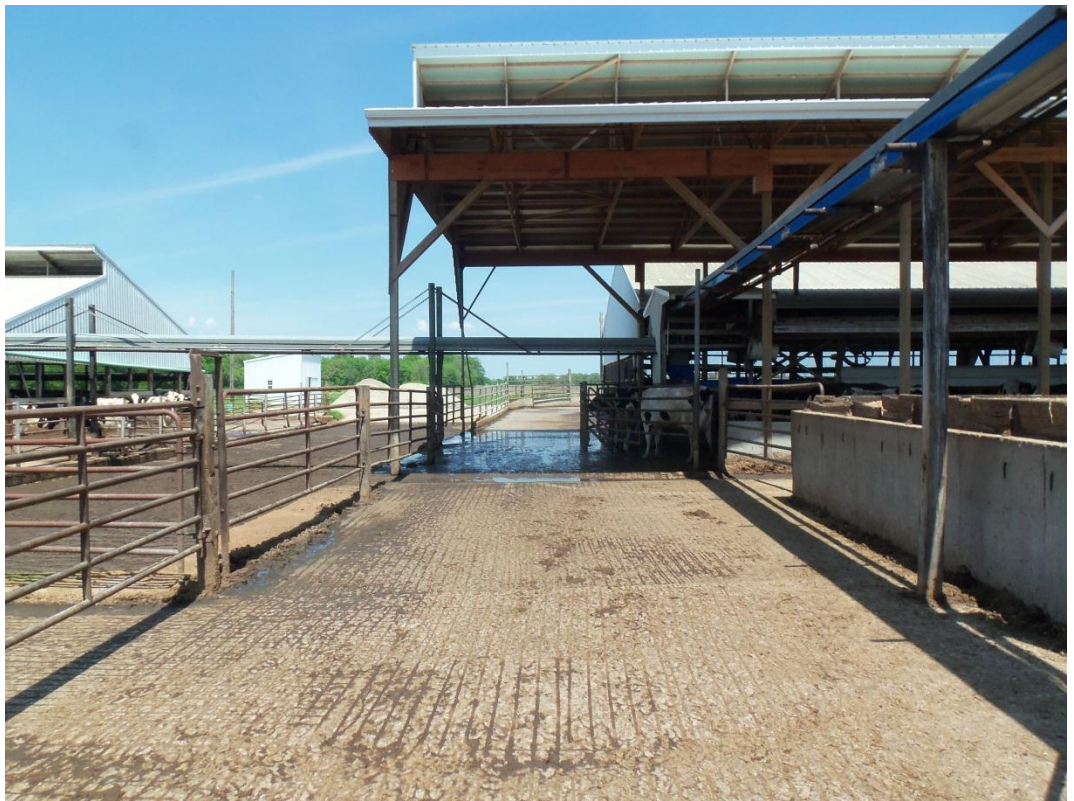
Photo #: 002
Date: May 8, 2013
Time: 11:15 a.m.
Taken By: Brian Rodely DWPC/FOS
Facility: Thole Ag, Inc.
Location: S of High Herd Building
Notes: This is photograph a
portion of the concrete
feedlot area and one of the
concrete settling basins.
Note that the building is
equipped with guttering.

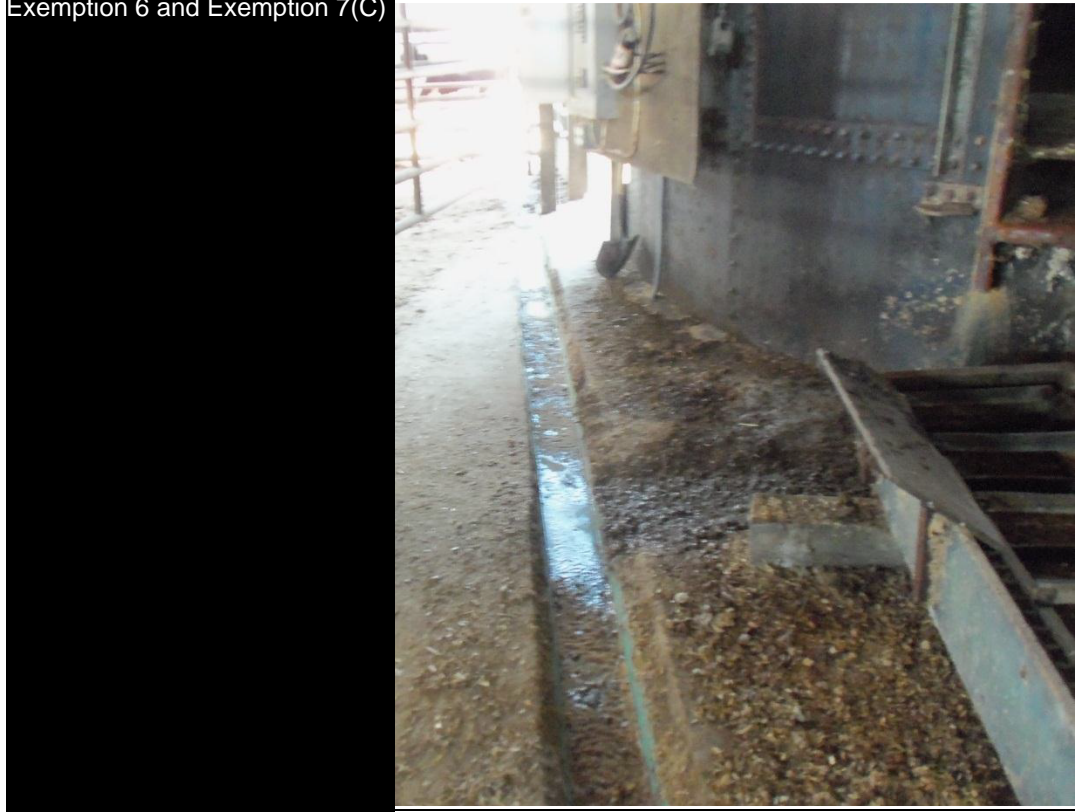
Photo # 003
Date: May 8, 2013
Time: 11:45 a.m.
Taken By: Brian Rodely DWPC/FOS
Facility: Thole Ag, Inc.
Location: N of "pre-fresh" barn
Notes: This is a photograph of a gutter constructed to convey away from the buildings to the waste containment system.

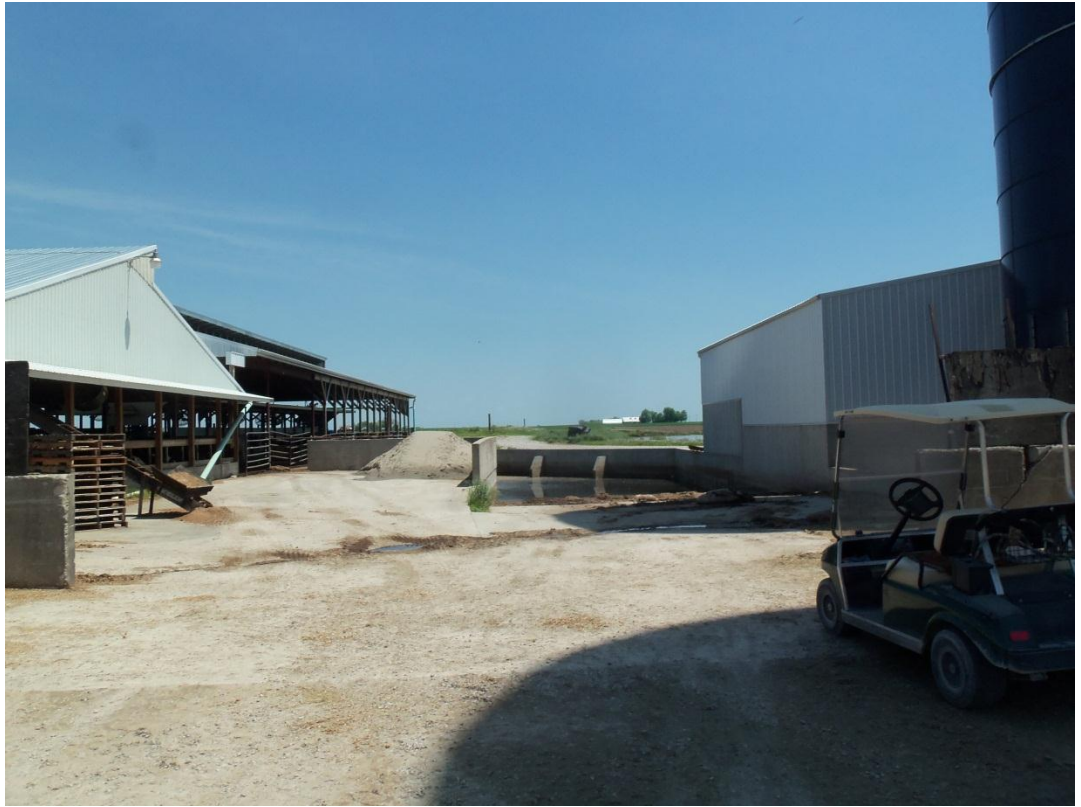
Photo # 004
Date: May 8, 2013
Time: 12:00 p.m.
Taken By: Brian Rodely DWPC/FOS
Facility: Thole Ag, Inc.
Location: West of the concrete pit
Notes: This is a photograph of the concrete pit and sand storage area.

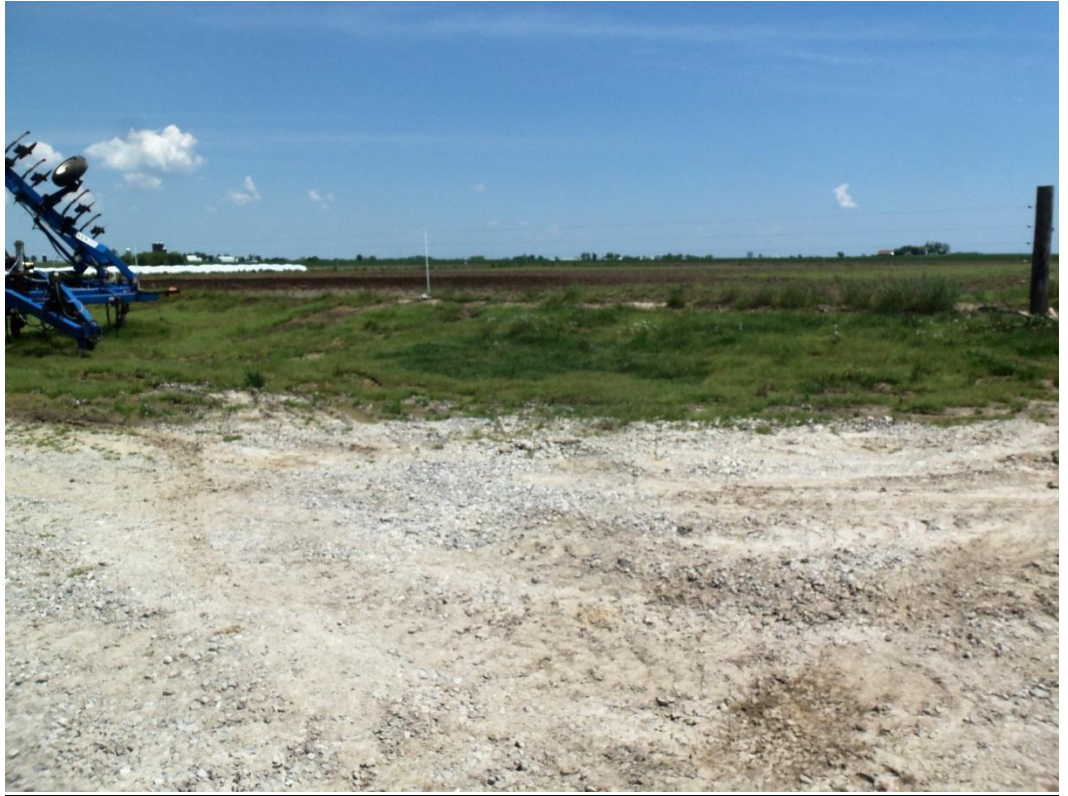
Photo # 005
Date: May 8, 2013
Time: 12:15 p.m.
Taken By: Joe Stitely DWPC/FOS
Facility: Thole Ag, Inc.
Location: SW of earthen feedlot.
Notes: This is a photograph of the facility's "dry lot" earthen feedlot.

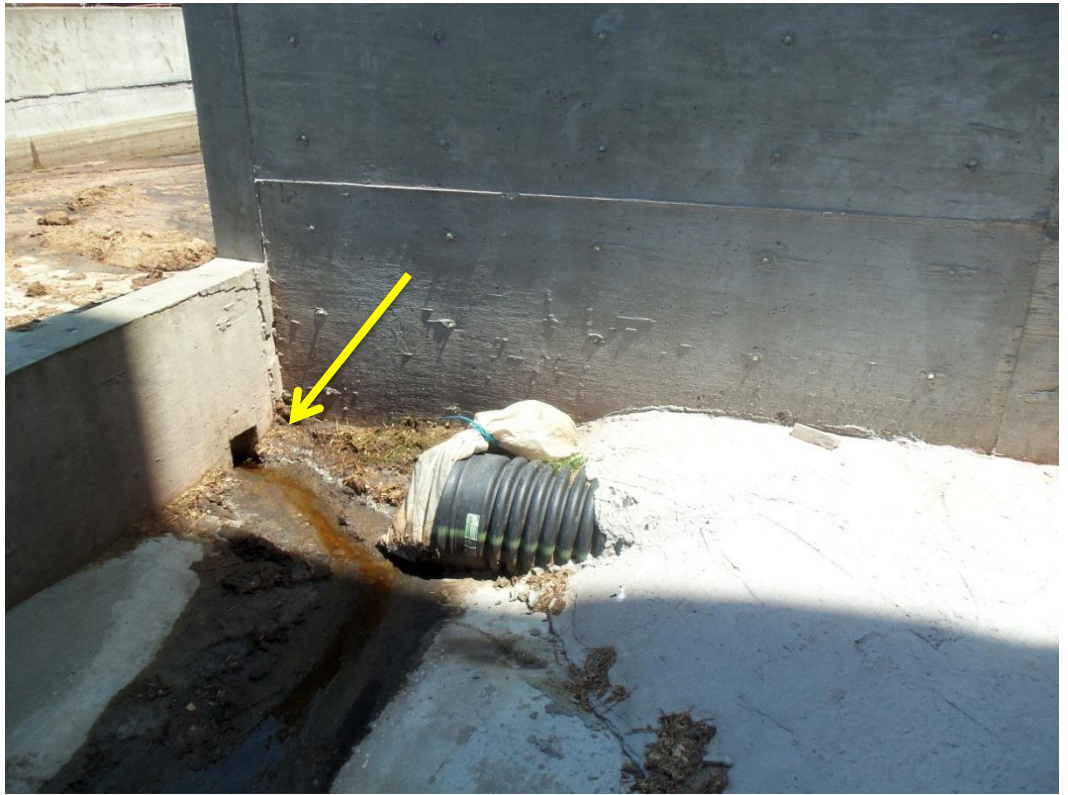
Photo # 007
Date: May 8, 2013
Time: 12:30 p.m.
Taken By: Joe Stitely DWPC/FOS
Facility: Thole Ag, Inc.
Location: SW of Concrete Pit
Notes: This is a photograph of tile that can be used to discharge livestock wastes. Note the box cut out of the retaining wall. At the time of the inspection, a sand bag was covering the tile inlet to prevent discharge.
